# ROOF INSPECTION REPORT

## Sample Commercial Roof Inspection Report

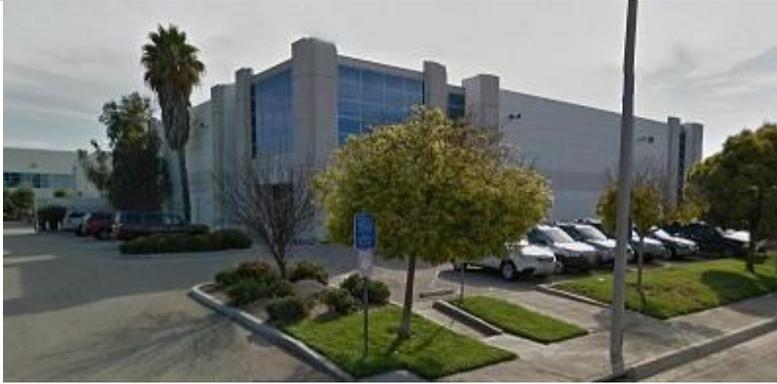
Observed facts; Tilt up concrete building with palletized roof assembly  
Professional Opinions:  
Generally in good condition overall with deferred roof maintenance.  
Limitations & assumptions  
No destructive testing was done for any of the information below.  
This is a picture of the front of the building.

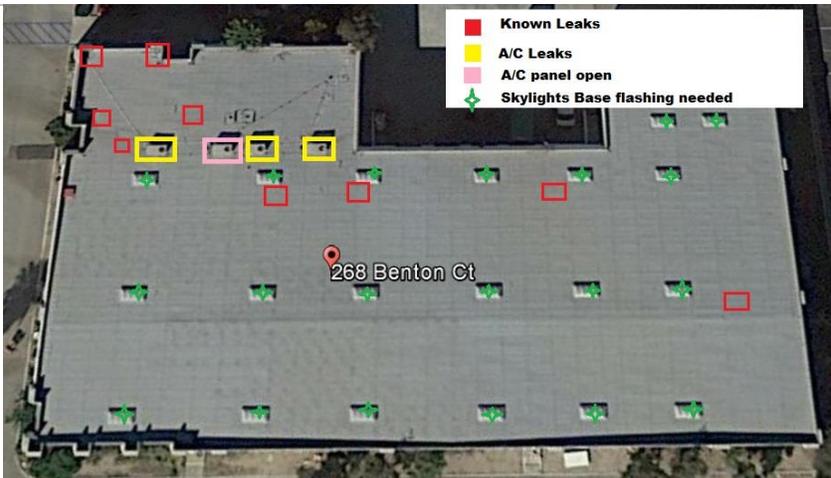
Observed facts; Cap sheet roof - mid life. That Pink A /C has a panel fallen off that needs to be reset in place.  
Professional Opinions: Cap sheet was in reasonable condition for its age- generally serviceable.  
Limitations & assumptions  
No testing was done for age.  
Colors blocks show various locations and their problems.

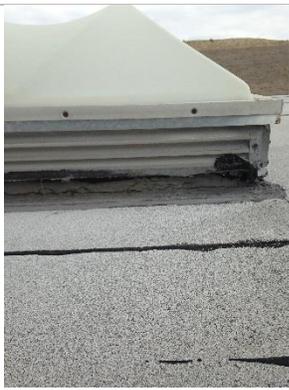
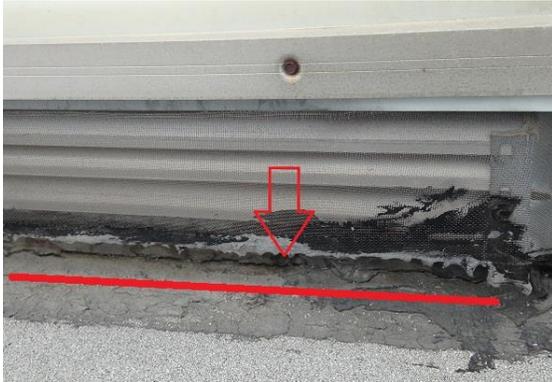
Observed facts; There are 20 skylights on the building approx size 4 x 8'  
Professional Opinions: The skylights themselves look Ok but the roofing around them is quite suspect.  
Limitations & assumptions: I did not dig into the roofing to see how far down those cracks go.  
This is a picture of the the side of a skylight. The close up shows a large crack in red line area. This is a very typical condition on all 20 skylights.

Mostly it's the skylights base flashings that are wide open that need to be sealed properly, causing some of your problems.

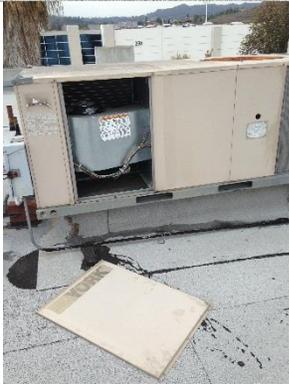
Observed facts; There are 4 A/C's on the roof.  
Professional Opinions: they are direct draft which means they are on a metal duct going directly down into the building.  
Limitations & assumptions This is not a HVAC inspection or report.  
This is the "pink" A/c in the photo above. Notice the side panel is not in place. Water blows in here and leaks.

The ac's also need to be sealed up because of their water proofing failure and there are leaks there too

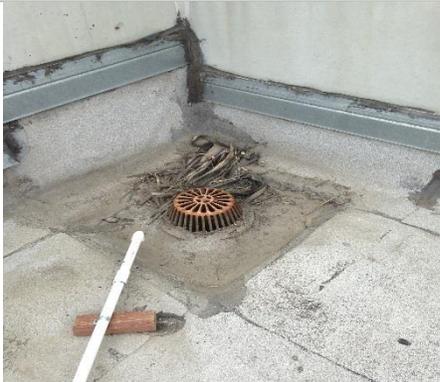
Observed facts; There are sump drains and overflows on the roof.  
Professional Opinions: The debris needs to be kept clear of the drains to prevent backup and leaks.  
Limitations & assumptions The drain function was not tested for water flow.  
This is a sample picture of the drains, note the patches and sealants used as evidence of long standing leaks.

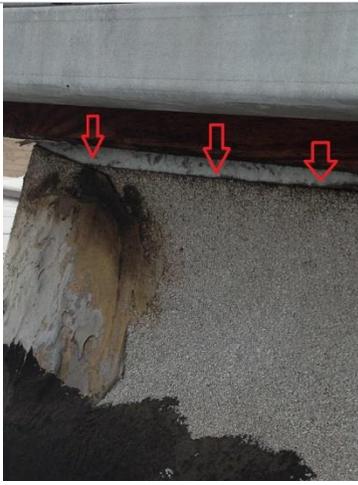
Observed facts; The direct draft a/c's have cap sheet (roofing paper) running up the sides of the duct beneath it.  
Professional Opinions: This roof sheet and others like it need to run all the way up under that wood for a proper seal. This is leaking from the water flowing down the sides of the A/c's, all (4).  
Limitations & assumptions  
Not sure if it ever ran all the way but shrinkage over years can happen.

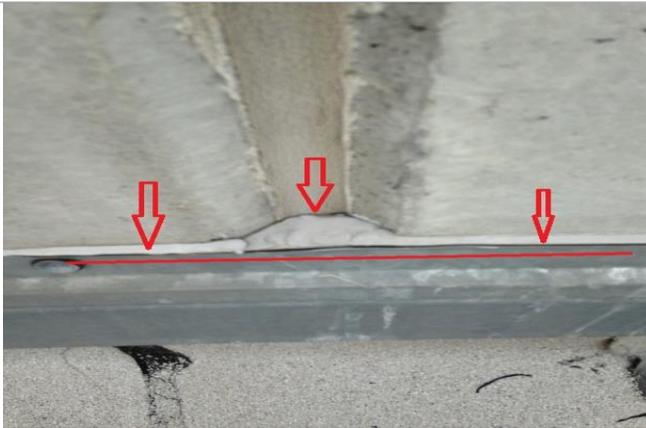
Observed facts; Tilt up concrete building have joints between the panels. This is a photo of one typical joint.  
Professional Opinions: The rubber between the panels must be complete and continuous for a proper seal.  
Limitations & assumptions  
Not every joint was examined.  
The red line shows the metal wall flashing which is open to water intrusion. This is typical of all wall flashings in various states of open.

The wall's metal flashings are in need of of sealant which will be good preventative care.

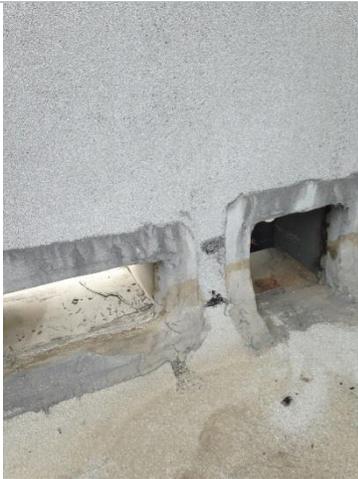
Observed facts; There are also through wall holes for drainage. These are called scuppers. The higher one is the overflow scupper.  
Professional Opinions: The metal in the scupper is rusty and the sealants have cracked.  
Limitations & assumptions  
No digging into the seals was done to test the penetration.

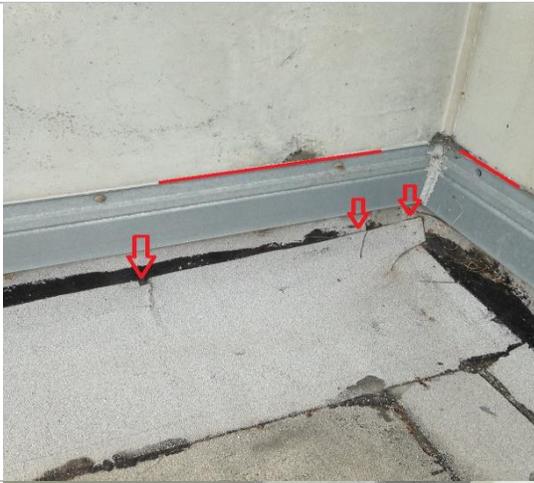
Observed facts; This repair patch does not run up under the wall flashings  
Professional Opinions: This will lead to water going behind the “patch and the same leak recurrence.  
Limitations & assumptions  
This sheet was not pulled back to see if the holes under were ever actually fixed. Those red arrows and lines are letting water in.

Failed patches done by others need to be corrected.

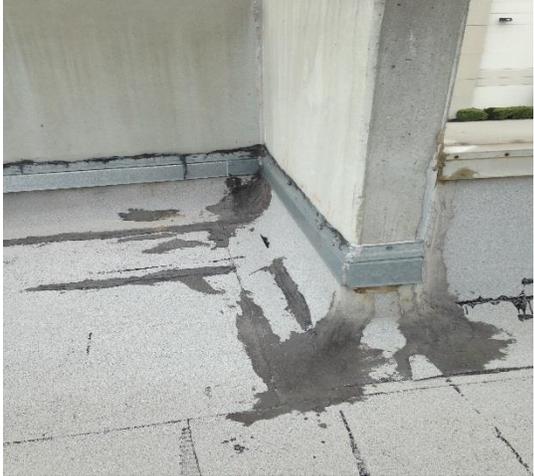
Observed facts; Someone tried to patch this corner, the wall flashing seals are open again despite the patches.  
Professional Opinions: These patches may have done by an inexperienced roofer. The sealant work doesn't make sense to me.  
Limitations & assumptions  
The effectiveness of this work is suspect as it still leaks directly below. The actual water may be flowing under the roof from a higher point some 20 feet away down to leak through here.

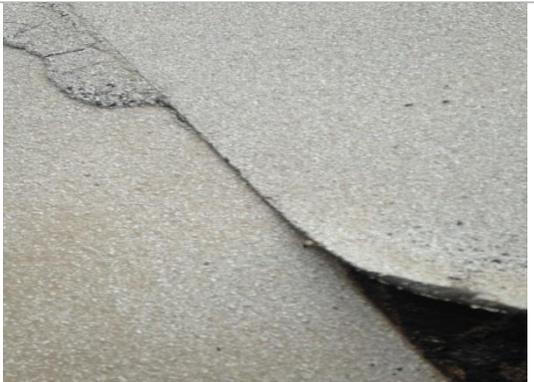
Observed facts; The cap sheet is loose in areas letting water in under it.  
Professional Opinions:  
Mostly open corners and edges but this is what opens first as a roof gets older. This spot may not be a leak today as the sheets under it are still good.  
Limitations & assumptions  
Not every corner or open area or sheet was found; this is just a sample of some overall conditions.

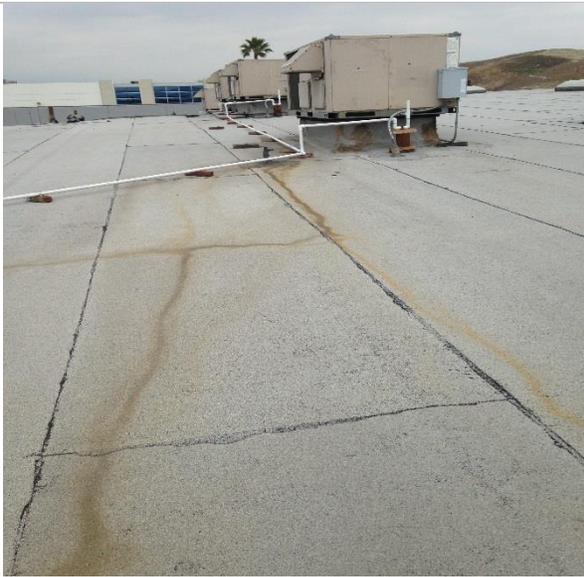
Observed facts; The a/c's are on the roof and the condensate lines run along the roof through white PVC pipes.  
Professional Opinions: There are considerable stains on the roof from rust likely from the exposed metal and water leakage.  
Limitations & assumptions  
This is a typical shot of the equipment and the stained waterway on the roof  
Notice the white cap sheet surface is somewhat worn off leaving black spots. This is signs of age.

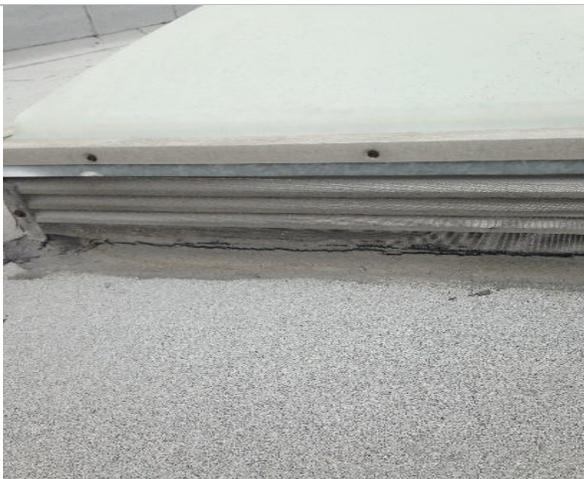
Observed facts; The cracks at the base of the skylights are common to all skylights  
Professional Opinions: This can easily be the source of SOME of the roof leaks but not all.  
Limitations & assumptions  
Not every leak was isolated to its source just the close proximity was noted to the known leaks and cracks or holes in the roofing.

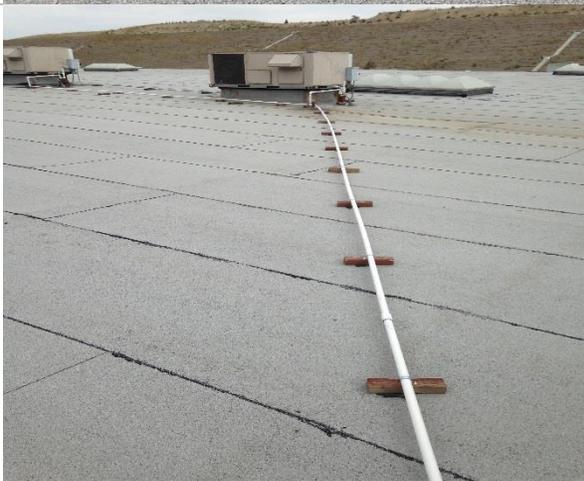
Observed facts; The top roof layer (cap sheet) is generally good but showing worn through areas.  
Professional Opinions: This roof has life still and usually to handle it, if desired, a new roof coating would be done to add 5 to 10 more years of life before a full reroof is done.  
Limitations & assumptions  
Exactly how long the roof will last is unknown.
